MARINE ACCIDENT INVESTIGATION BRANCH

FLYER TO THE LEISURE INDUSTRY

ORCA: accident leading to a fatality on 8 June 2014

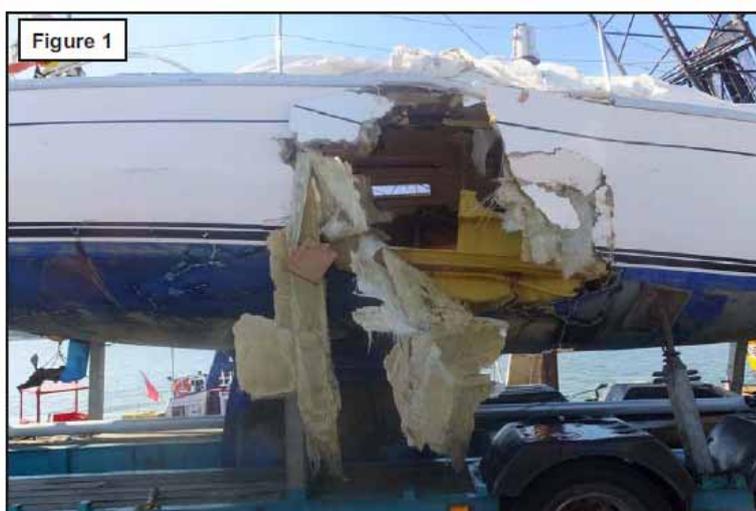
At 1331 on 8 June 2014 the dredger *Shoreway* and the sailing yacht *Orca* collided 7 miles off Felixstowe. Damage to *Orca* was catastrophic (**Figure 1**) and it sank within minutes of the collision. The yacht's skipper was rescued from the water by *Shoreway's* rescue boat but the skipper's wife could not be found despite an extensive air and sea search. Her body was recovered from the sunken yacht by divers the next day. There was no damage to *Shoreway*.

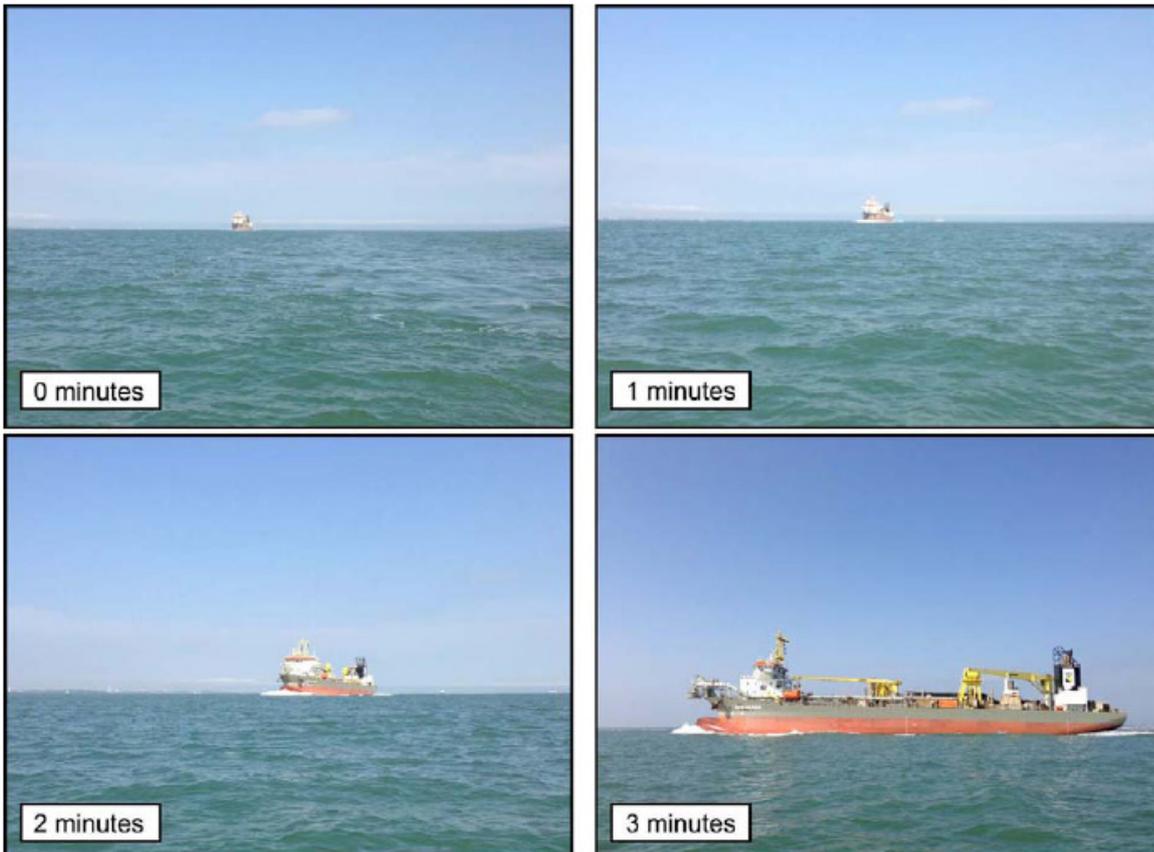
Leisure sailors need to be particularly aware of closing speeds between their own vessels and other vessels. In this case, *Shoreway* was travelling at 12.9kts but many types of vessels, including ferries, cruise ships and container ships, regularly sail at speeds over 25kts and, as a result, distances that initially appear sufficient can be reduced surprisingly quickly.

The following four pictures, taken from a stationary vessel, give an indication of how rapidly a vessel, in this case a dredger, can approach.
